RESEARCH REPORT

Report No. 2

August 1940

SERVICE LIFE OF UNTREATED JUNIPER AND CYPRESS
FENCE POSTS IN ARIZONA 7.1541

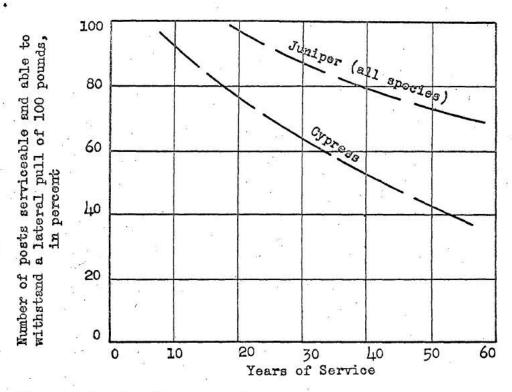
wood diameters for the three species of juniper and for cypress were almost identical. Diameter classes, therefore, can be disregarded, and one service-life curve is applicable for all posts of each species. The curves for the three species of juniper were also found to be almost identical (fig. 1). It may be concluded that, for all practical purposes, posts of the three native junipers are equally serviceable in the woodland zone. Data from the other zones, although less complete, indicate that this same relationship applies to them also. The service-life curve for cypress is also given in figure 1.

Fig. 1.- Service-life of juniper and cypress fence posts in the woodland zone. (Based on behavior of 815 juniper and 250 cypress posts.)

Juniper posts show a decided superiority over cypress posts for all ages sampled. At 40 years, 80 percent, and at 50 years, 74 percent of the juniper posts of all diameters and species withstood a lateral pull of 100 pounds, and were otherwise serviceable. Of the cypress posts, 54 percent at 40 years and 43 percent at 50 years showed similar serviceability. These data, in general, confirm the experience of those who have used posts of both juniper and cypress, namely, that although cypress posts sometimes remain serviceable for long periods of years, they are usually less dependable than those of juniper.

Until the factors that control the service life of untreated cypress posts are more fully understood, the use of cypress posts in permanent fences should not be encouraged, unless the posts are given a preservative treatment prior to use.

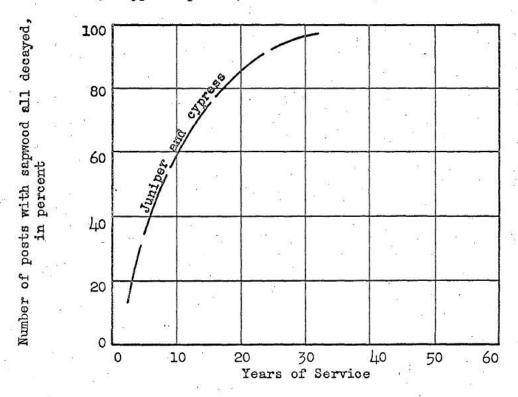
Fig. 2.- Decay of sapwood in relation to length of service for juniper and cypress fence posts combined. (Based on behavior of 2,316 posts from all climatic zones in Arizona.)

It is widely recognized that the sapwood of practically all species of woods, when untreated, is short lived, when used under conditions that favor decay 3/. The cypress and juniper sapwoods are no exception; for in spite of the marked difference in durability of the heartwoods, the sapwoods of juniper and cypress were found to be about equal in durability. The sapwood at the ground level on 60 percent of the sample posts of juniper and cypress was decayed after 10 years of service; and on over 80 percent of the posts, after 20 years of service. (Fig. 2.)

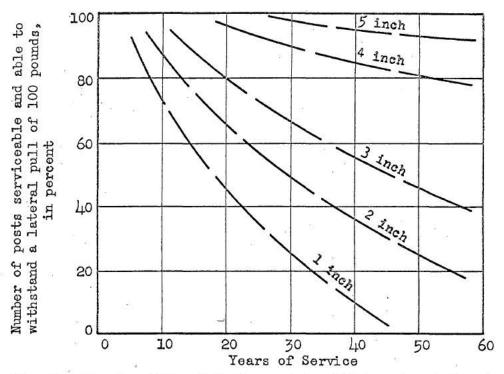
Fig. 3.- Service-life of juniper posts with heartwood diameters varying from 1 to 5 inches at ground level. (Based on behavior of 2,066 posts from all climatic zones in Arizona.)

It is obvious that posts with a heartwood core of 2 inches or less at the ground line do not render satisfactory service in any of the four climatic zones, and that posts with a heartwood core of 5 or more inches at the ground line render service far above this minimum standard in all zones. (See fig. 3.) Hence, the minimum heartwood diameter for each zone must be determined largely by the behavior of the posts that fall into the 3- and 4-inch heartwood-diameter classes. Accordingly, the data for the 3- and 4-inch classes were again reanalyzed by zones. It was found that posts with 3 inches of heartwood at ground line would meet the minimum standard for fences in the desert

zone; that $3\frac{1}{2}$ inches would be required in the woodland zone, and that 4 inches would be necessary in both the saw-timber and irrigated zones. These minimum permissible heartwood diameters, with their corresponding butt heartwood diameters, are presented in table 3.

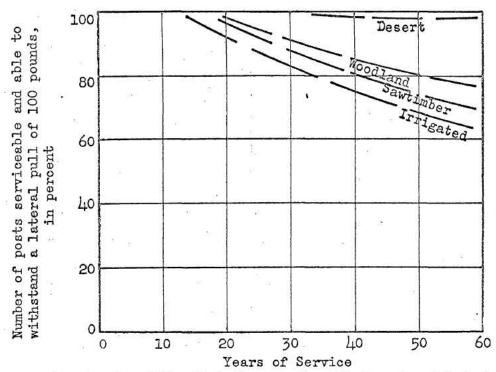
Fig. 4.- Service-life of juniper posts with heartwood 3 inches in diameter and larger at the ground line in the four broad climatic zones. (Based on behavior of 1678 juniper posts

In order to check this conclusion, the posts with 1- and 2-inch heartwood cores were eliminated from consideration, and only those with 3-inch and larger cores were reanalyzed by zones. The results, which are graphically given in figure 4, show that after 40 years of service, 98 percent of the juniper posts with heartwood cores 3 inches and greater in diameter were able to resist a lateral force of 100 pounds, to which a fence may be subjected, and otherwise are serviceable when used in the desert zone of low decay hazard; that 85 percent of posts of similar service length and size are serviceable when used in the woodland zone; 81 percent in the saw-timber zone; and 75 percent on irrigated lands, where decay conditions may be most severe. These facts indicate the great durability of the heartwood of the Utah, one-seed, and alligator junipers of the Southwest, when used as posts in contact with soil.
